Date: December 12, 2013**Project No.:** 013-1646-013.500.01**To:** Will Ernst**Company:** The Boeing Company**From:** Denise Carscadden, PE**Email:** dcarscadden@golder.com**cc:** Kent Angelos and Ted Norton, Golder Associates Inc.**RE: BUILDING 2-09 FIRE SERVICE DISCONNECT AT 2-10 AREA FIRE HYDRANT COMPLETION**

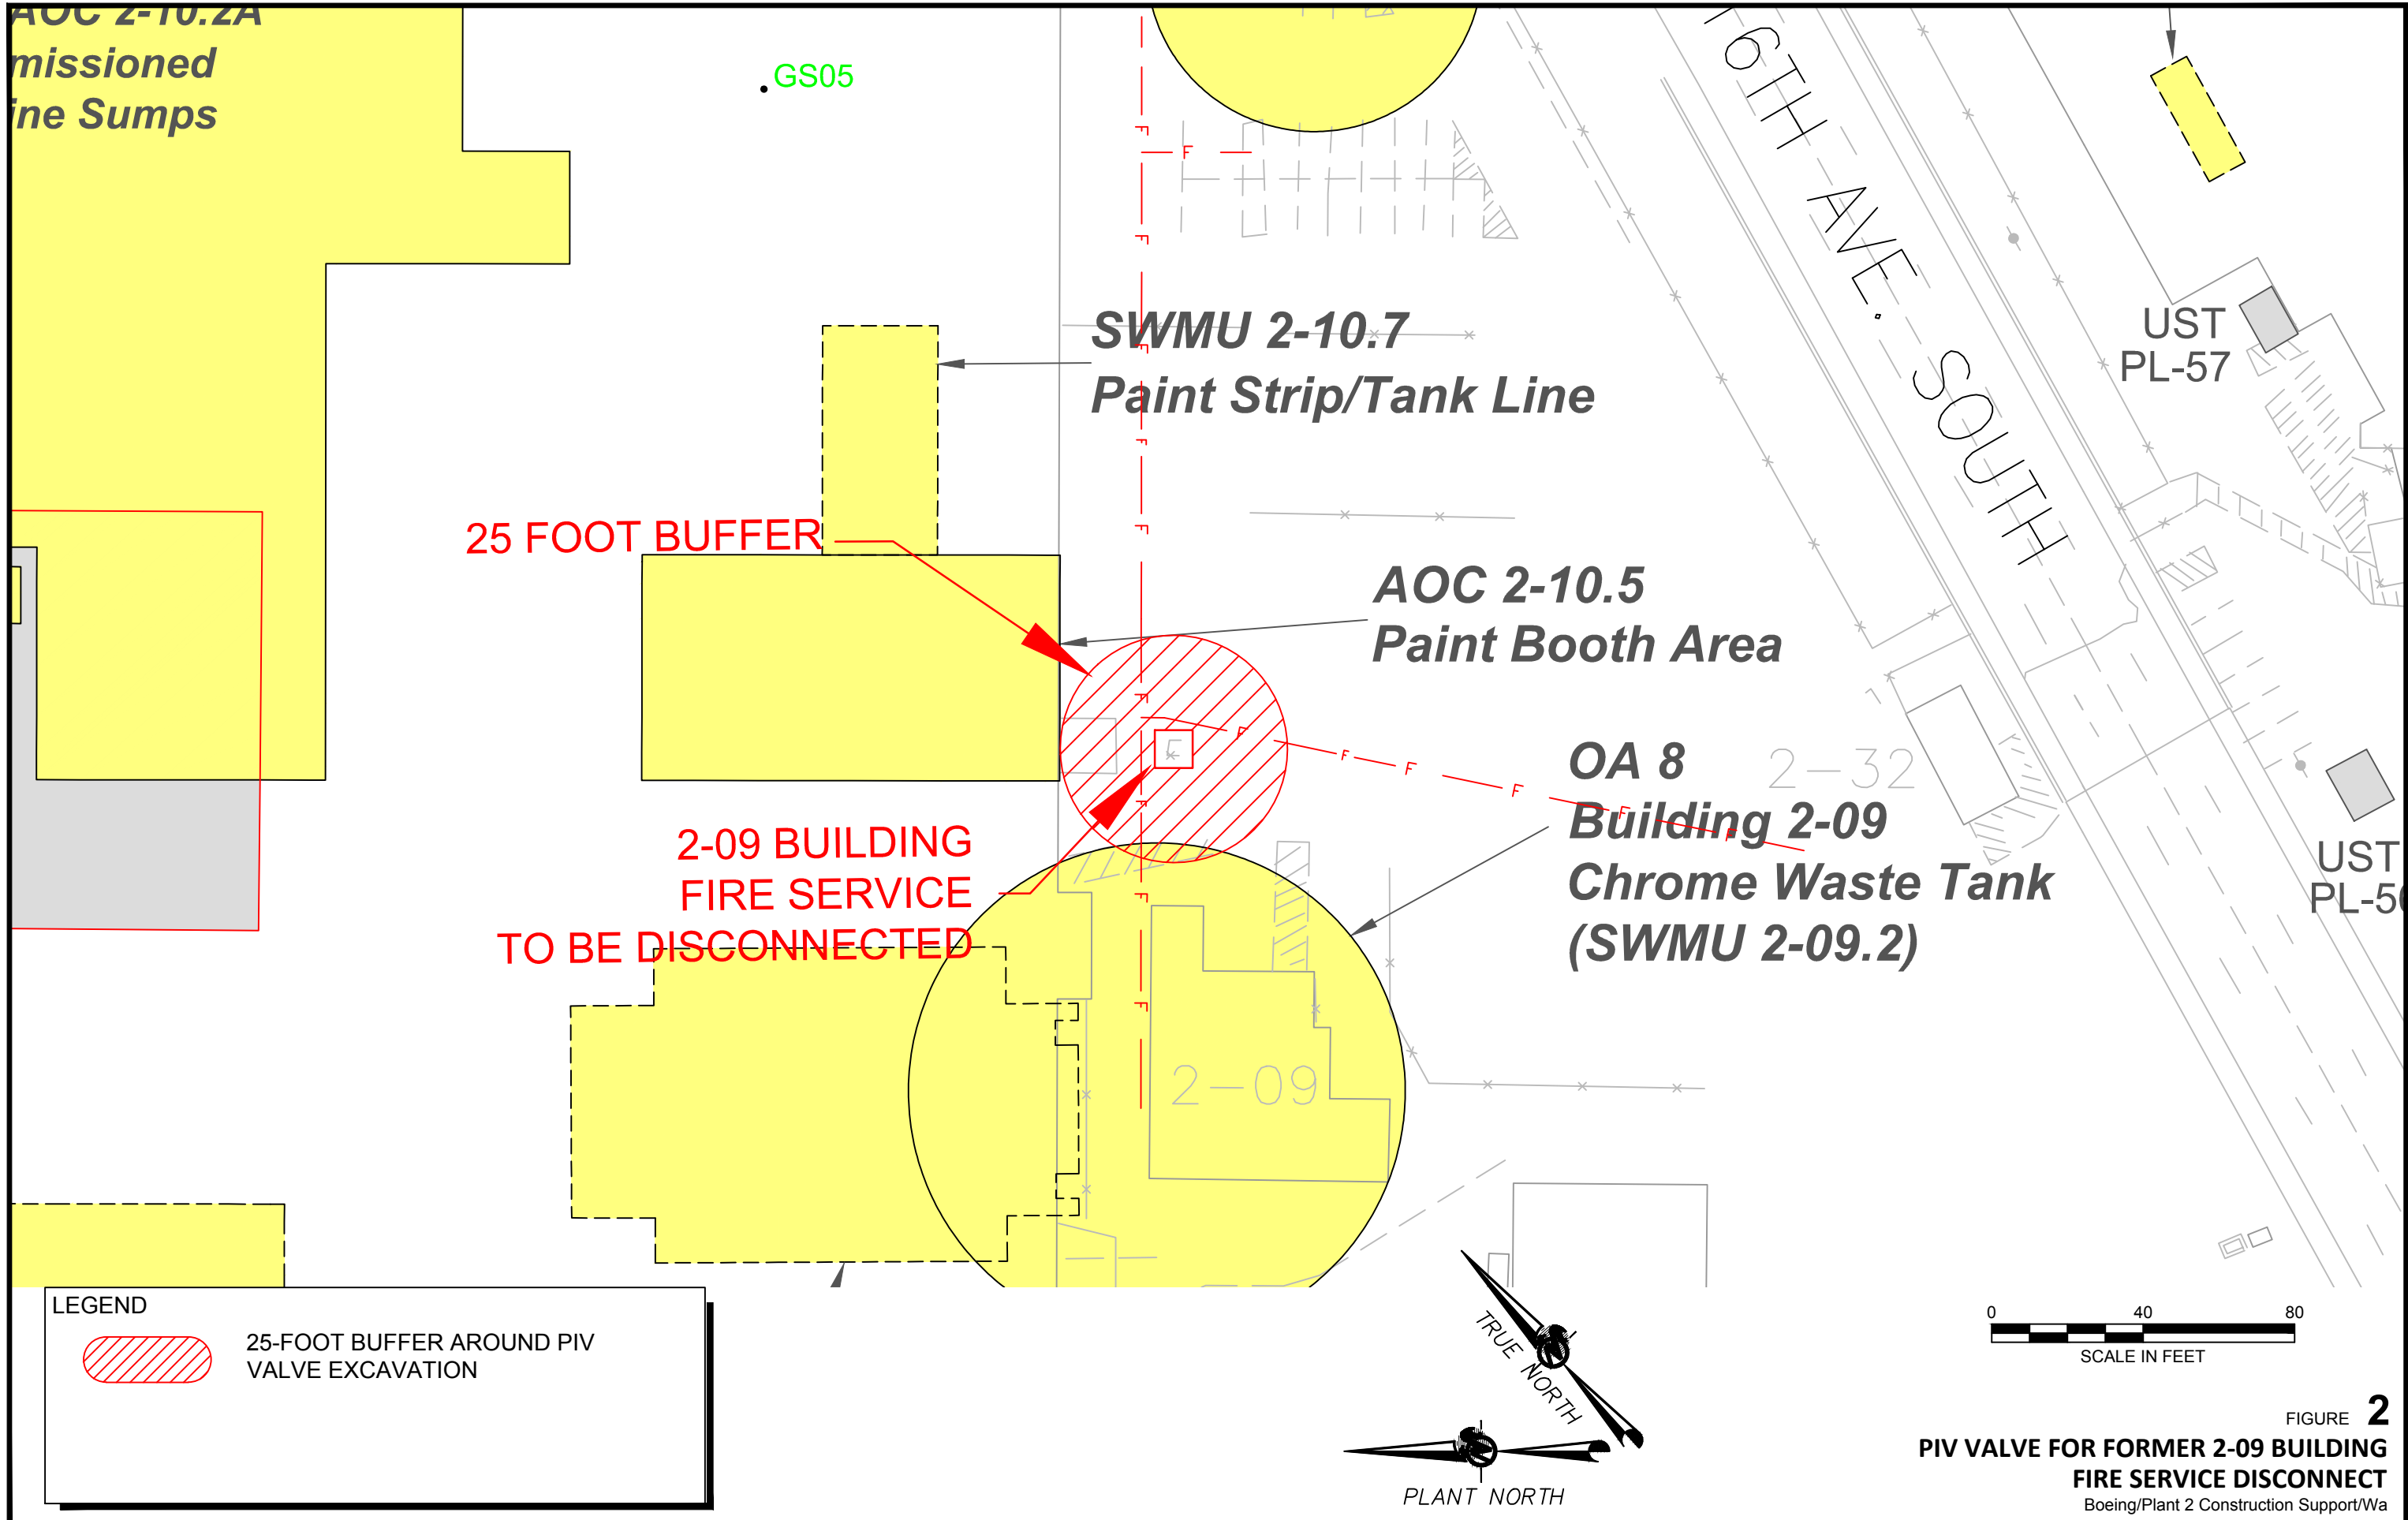
| Figure 2 | PIV Valve for Former 2-09 Building, Fire Service Disconnect |

The Boeing Company (Boeing) recently completed demolition of the 2-09 Building above ground structure down to the concrete slab at the Plant 2 Facility in Seattle/Tukwila, Washington. To complete the demolition Boeing disconnected fire water service to the former building to stop a leaking service line. Boeing accessed the service line at a fire hydrant on the south side of the 2-10 Building approximately 75 feet from the 2-09 Building (Figures 1 and 2). On November 11, 2013, a small excavation (maximum of 6 feet deep) was completed to remove the 2-09 Building service. The excavation required the removal of pavement, primarily in base rock, pipe bedding and fill materials, and resulted in the removal of approximately 3 cubic yards of material. Because of the simplicity of the excavation, design figures are not provided.
